Manhole Inspection Summary

Manhole # S33UU1007MH

Insp Date: **1/29/07 12:57 PM**

Location Address: **224 PADDINGTON RD**

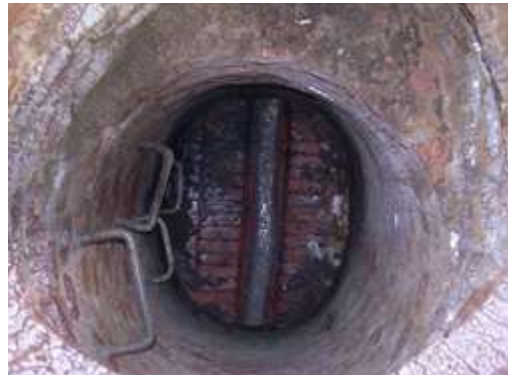
Top View

Evidence of surcharge - Bench debris.

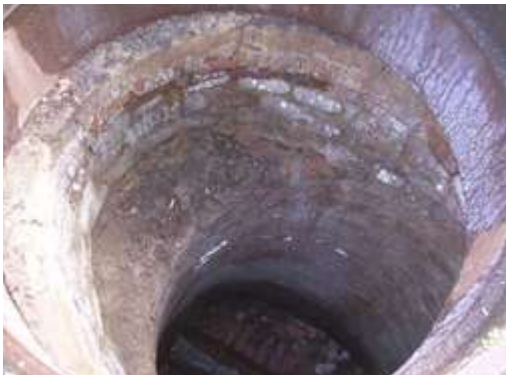
Defect

Frame leak, adjustment infiltration

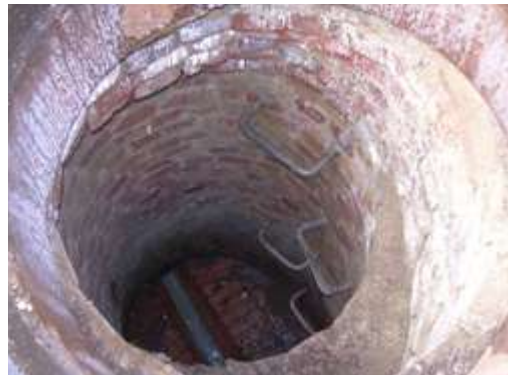
Defect

Frame leaks. Adjustment deterioration and infiltration. Barrel infiltration.

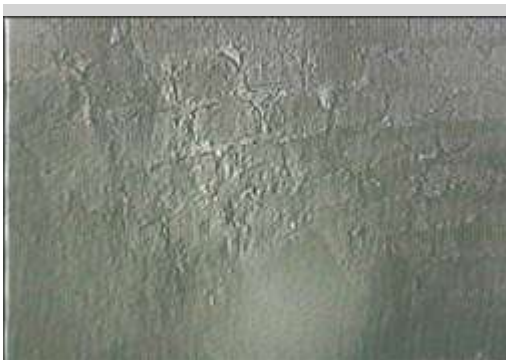
Defect

Barrel deterioration and infiltration.

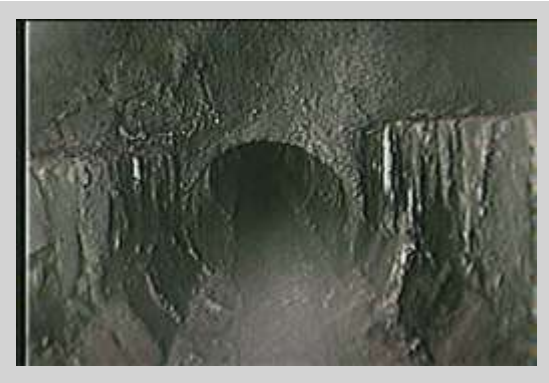
8 in. Circular Gravity Sewer Pipe Out @ 12 O'Clock

Deposits: ☐ None ☐ Mud ☐ Sludge ☐ Debris ☒ Grease

Silt Depth: **0** (in.) Deposits Extent: **Light**
